**ECOPOWER'S COLD WELDING TECHNOLOGY IS TESTED BY THE MCGM TO REPAIR A CAST IRON VALVE CONTAINING A CRACK.**

BMC officials summoned Ecopower to repair a cast iron piping system, located five feet underground at Kemps Corner in Mumbai. The test was carried out at 0100 hrs on the 25<sup>th</sup> of February 2010.

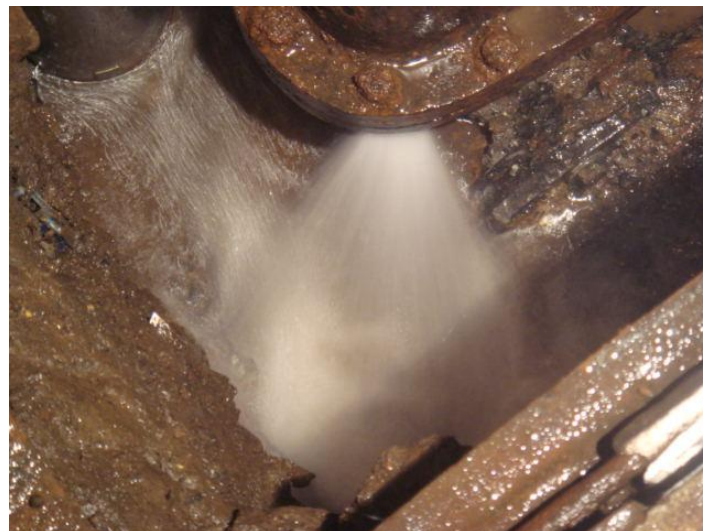
HIGH PRESSURE, CAST IRON VALVE LEAKING

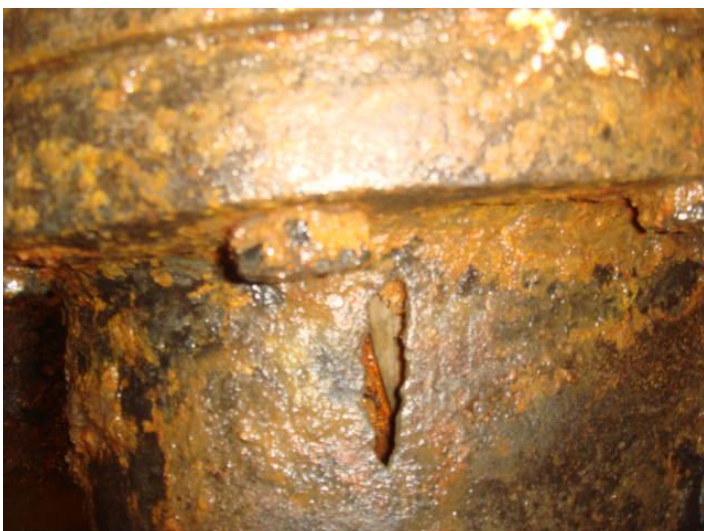
CRACK DETECTED AT THE HOUSING VALVE
